**THE CALIFORNIA EARTHQUAKE OF APRIL 18, 1906**

**REPORT**

**STATE EARTHQUAKE INVESTIGATION COMMISSION**

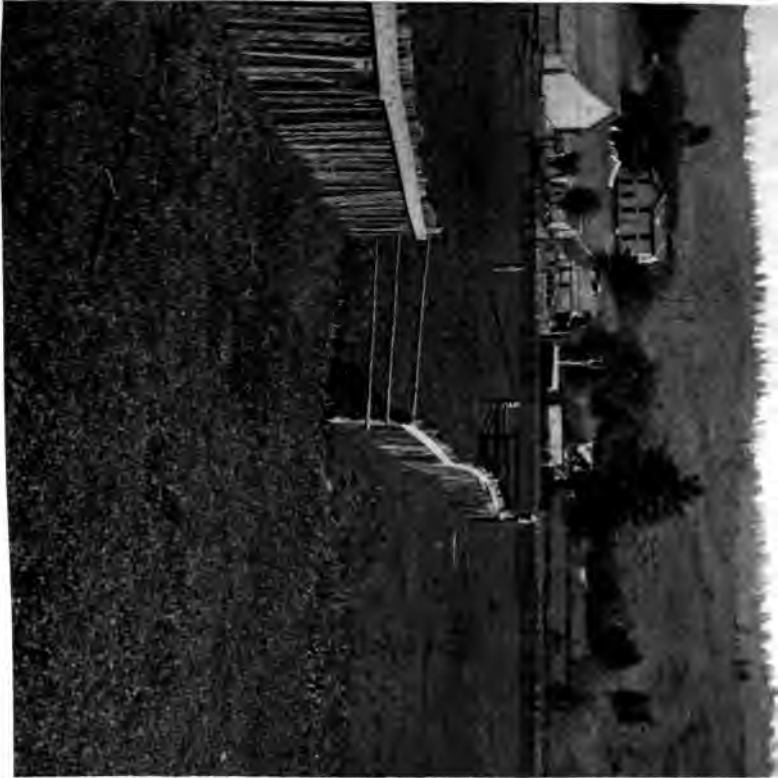
A. Fence offset by fault. Looking northwest. Camera was aimed with straight part of fence beyond the disturbance, to bring out flexure as well as offset of fence. G. K. G.

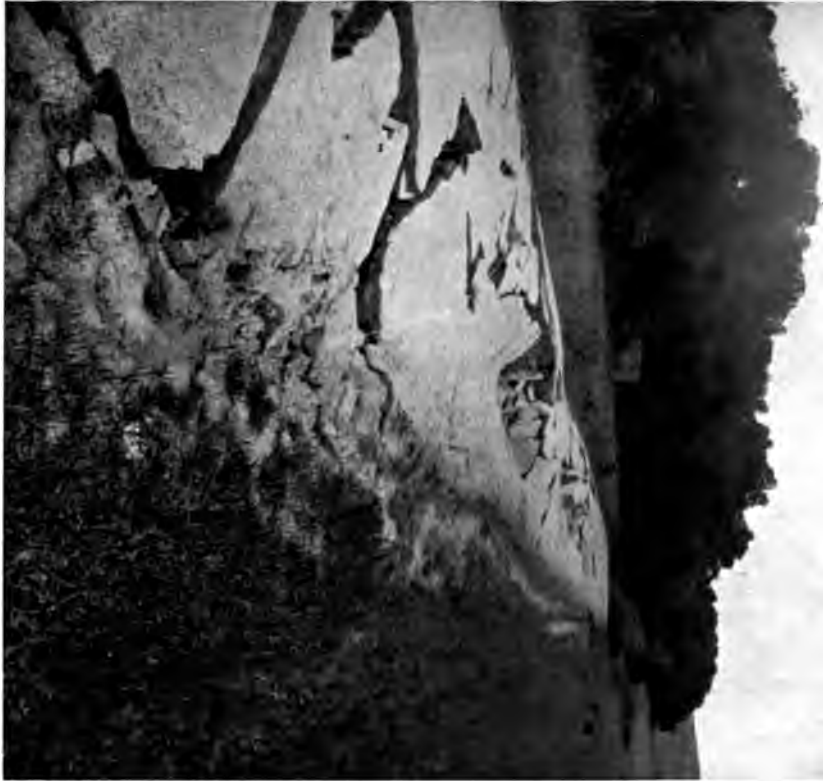
A. Road embankment broken by shaking of soft ground beneath. Southwest of Point Reyes Station and 10 rods from fault-trace. G. K. G.

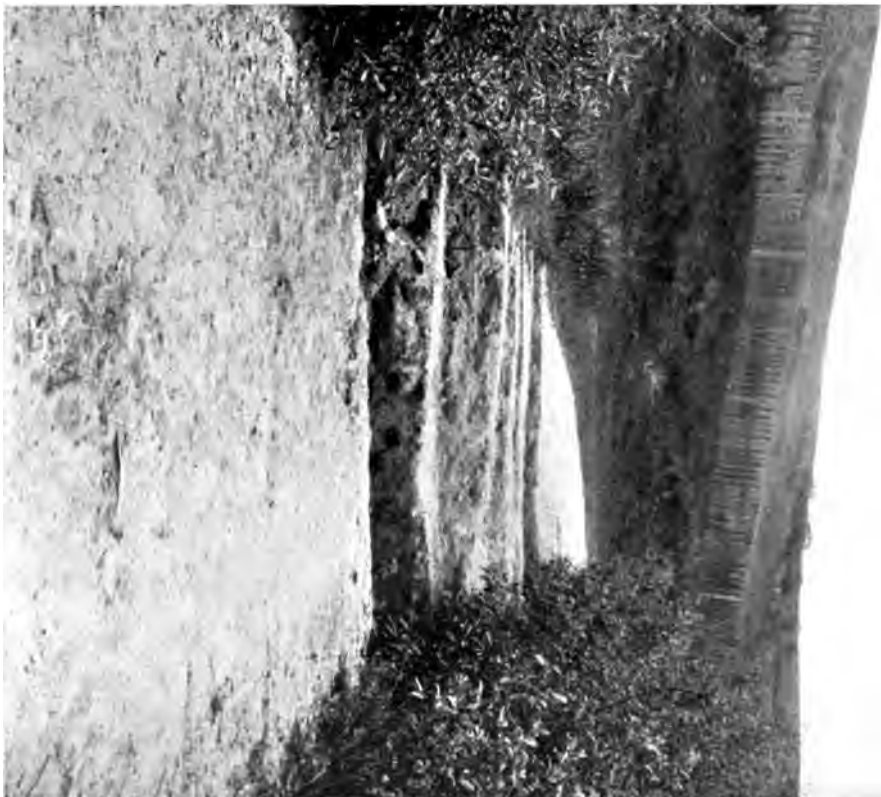
B. Faults in road embankment, southwest of Point Reyes Station. Fault-trace is beyond fence. Ground lurched toward marsh of Bear Valley Creek. G. K. G.

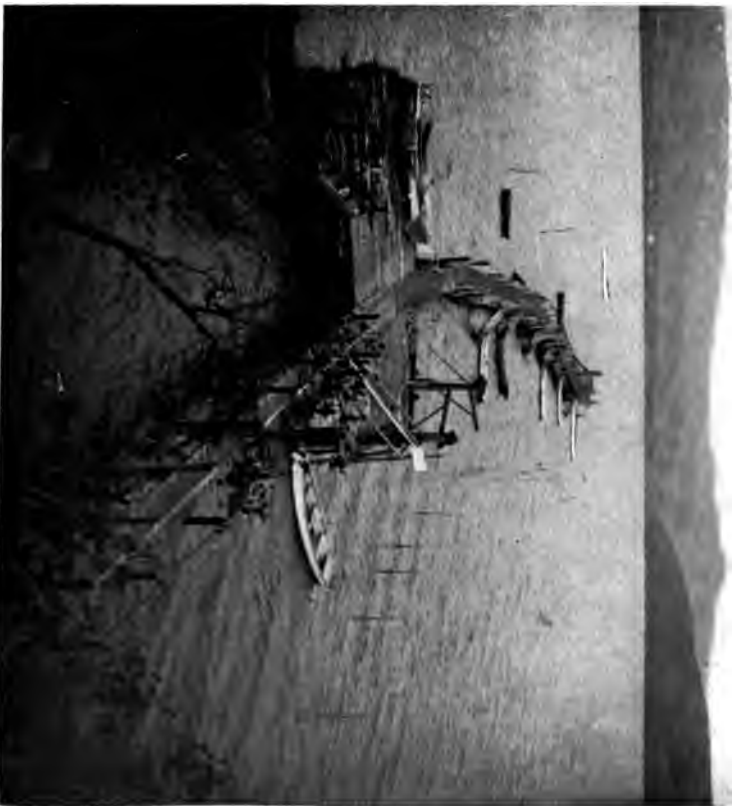
B. Bailey's pier at Inverness. Originally straight; shifted and much broken by earthquake. In subsequent repairs curvature caused by earthquake was retained. G. K. G.

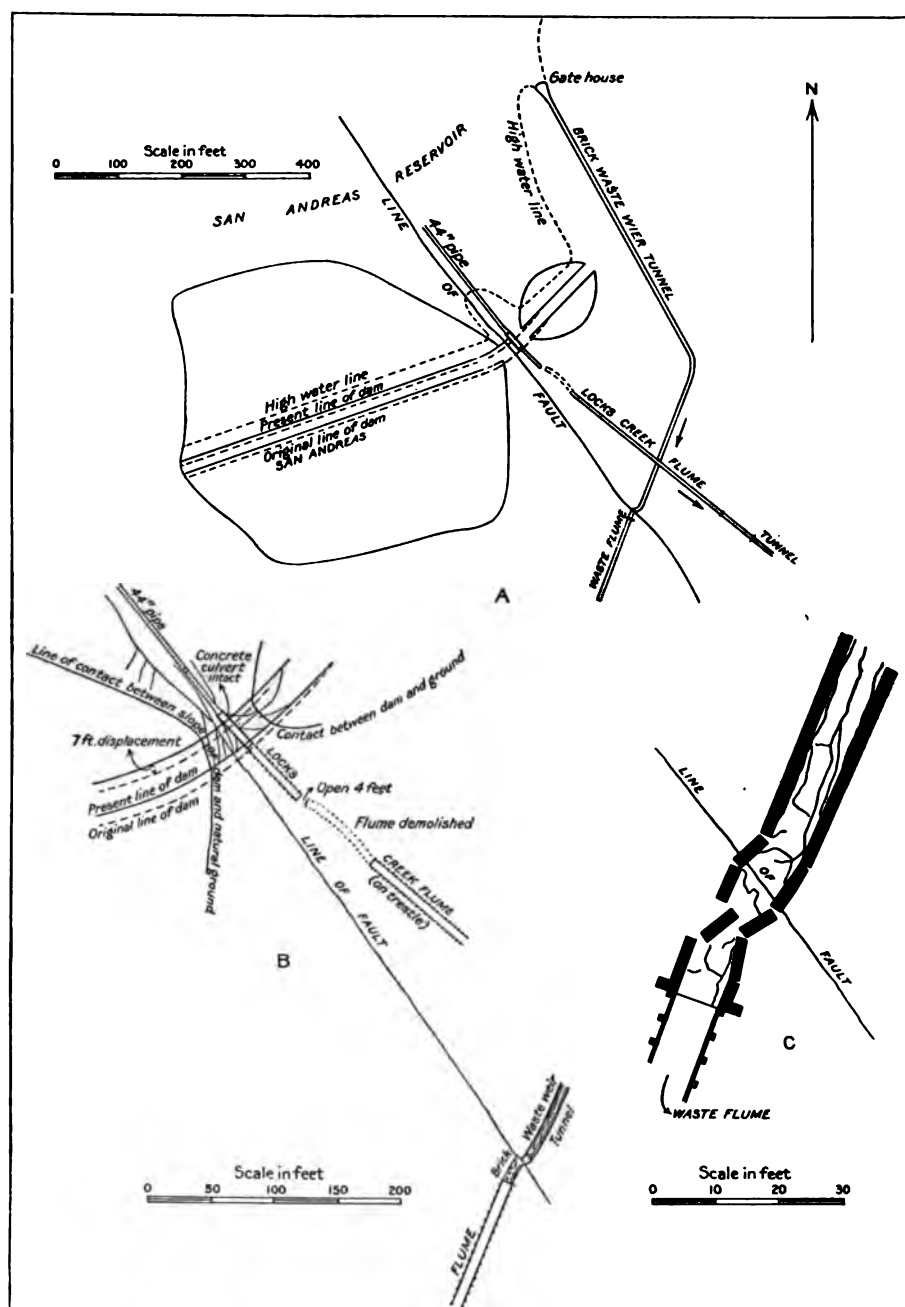
FIG. 36. — Intersection of San Andreas dam by fault. A. Plan of dam in two parts, with rock between. B. Relation of dam to waste weir tunnel. C. Detail of waste weir tunnel.

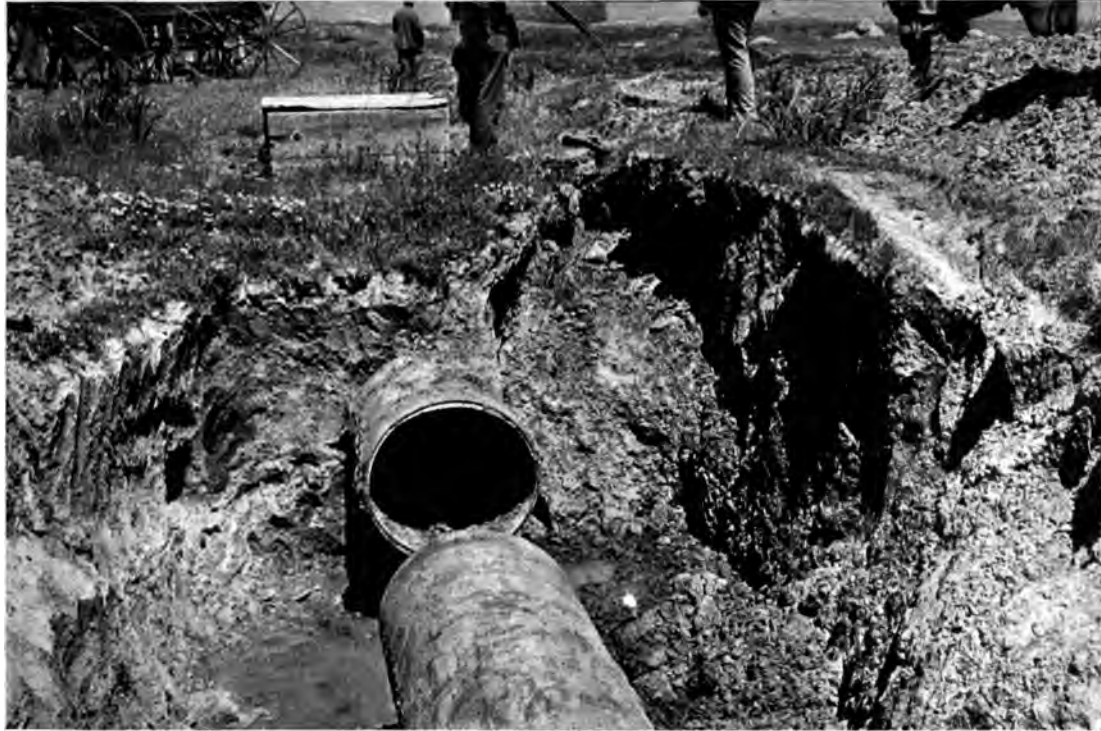
A. Rupture of 30-inch water-pipe by fault. Northwest of San Andreas Lake. A. C. L.

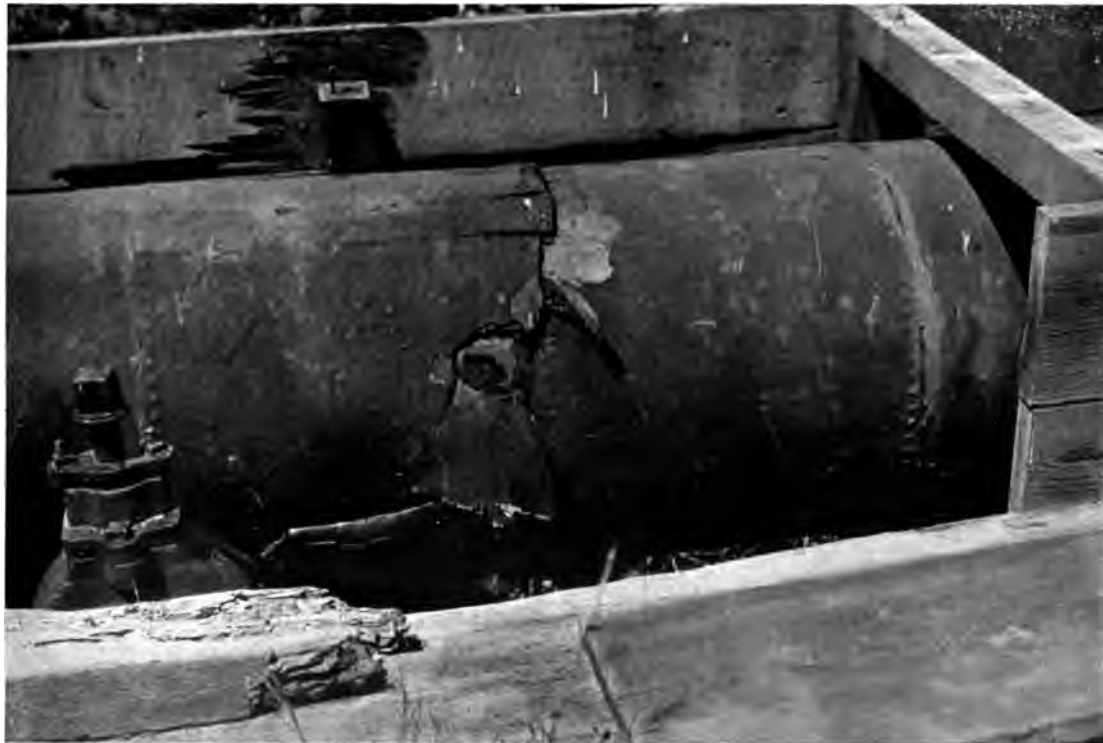
B. Thrust of 30-inch water-pipe by fault, northwest of San Andreas Lake. Amount of telescoping is 58 inches. A. C. L.

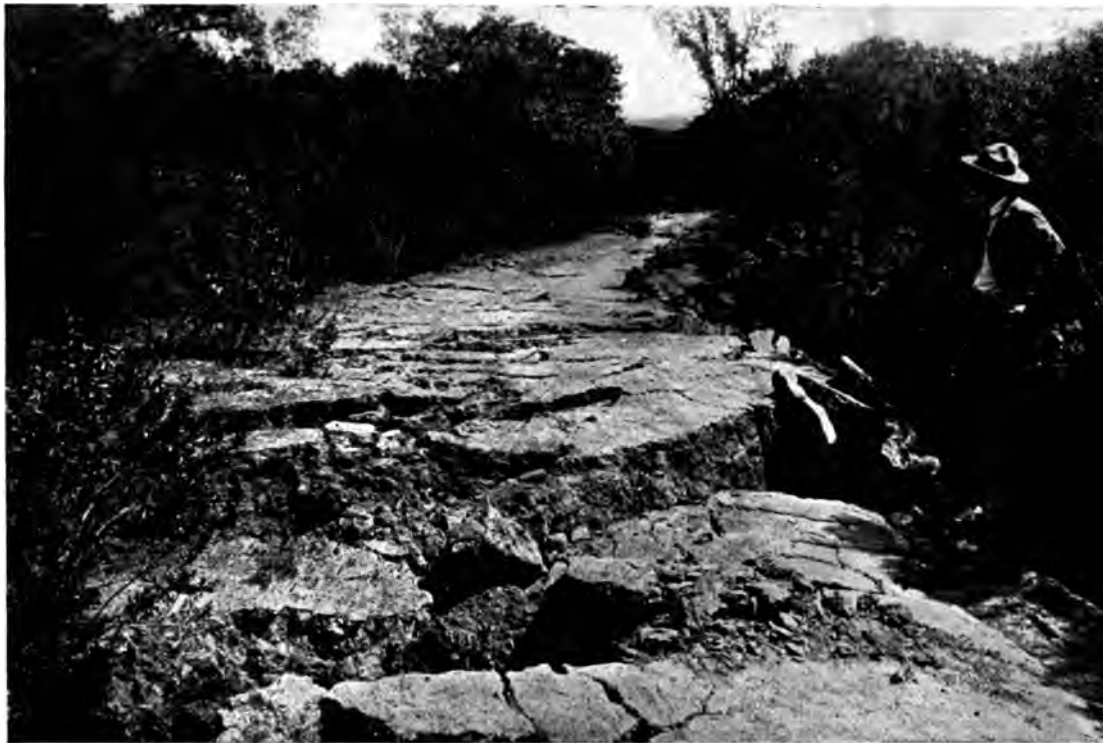
A. Offset of Alpine road 5 miles west of Stanford University. Per J. C. B.

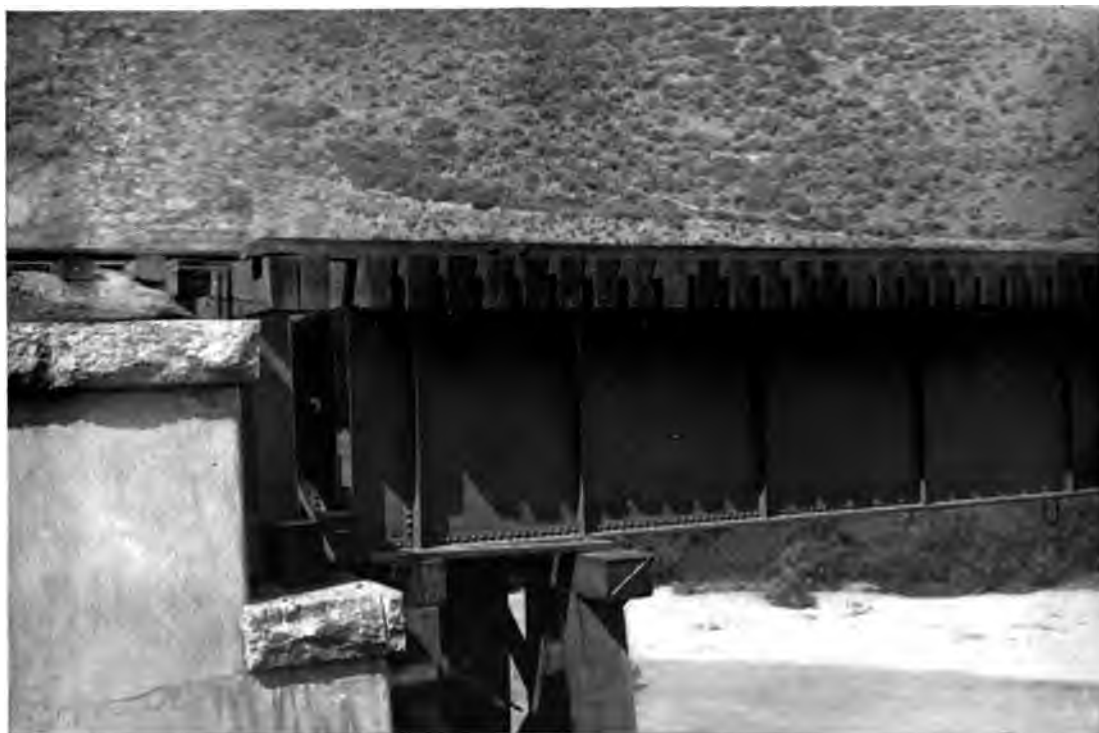
B. Steel bridge over Pajaro River, near Chittenden, dragged from its abutment 3.5 feet. Compare Fig. 43. A. O. L.

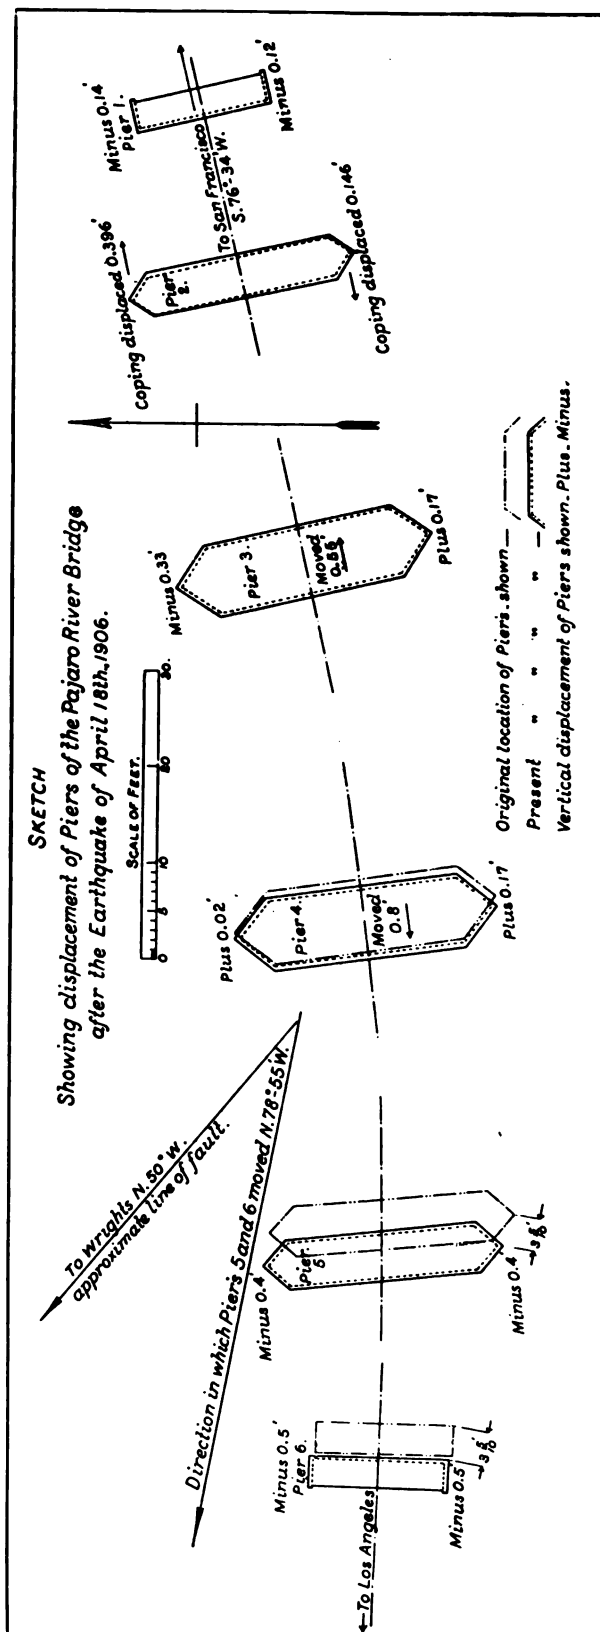
FIG. 43.—Displacement of piers of steel bridge at Chittenden.

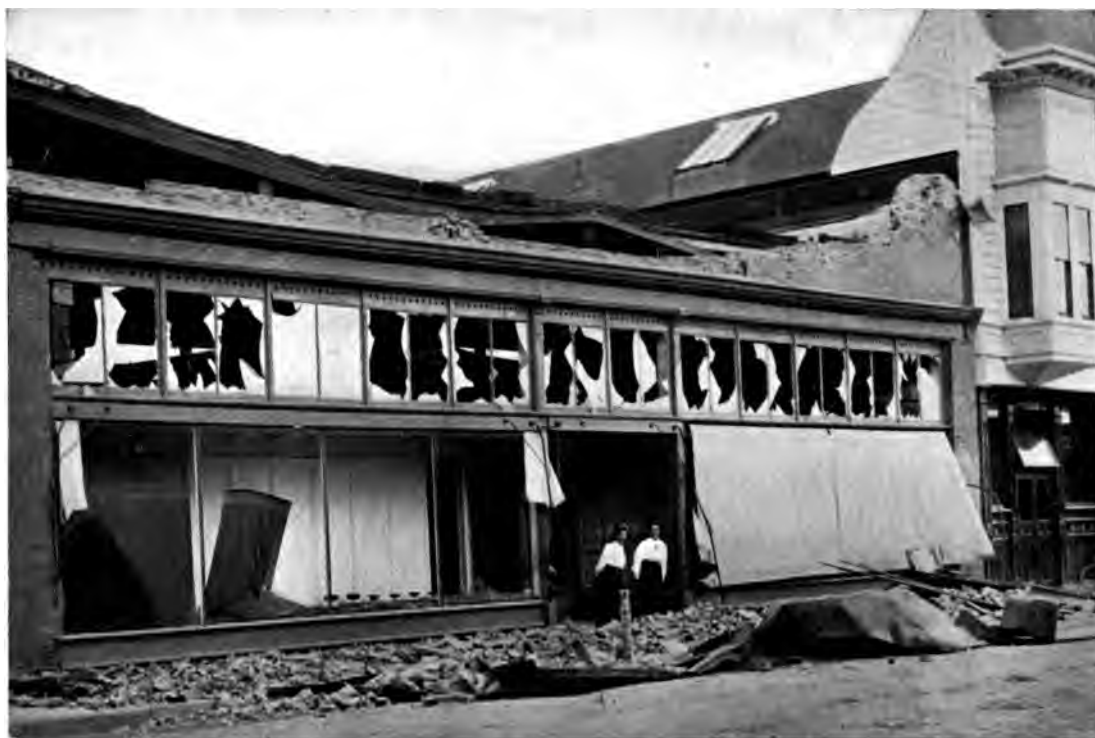
A. Wrecked stores. Ferndale, Humboldt County.

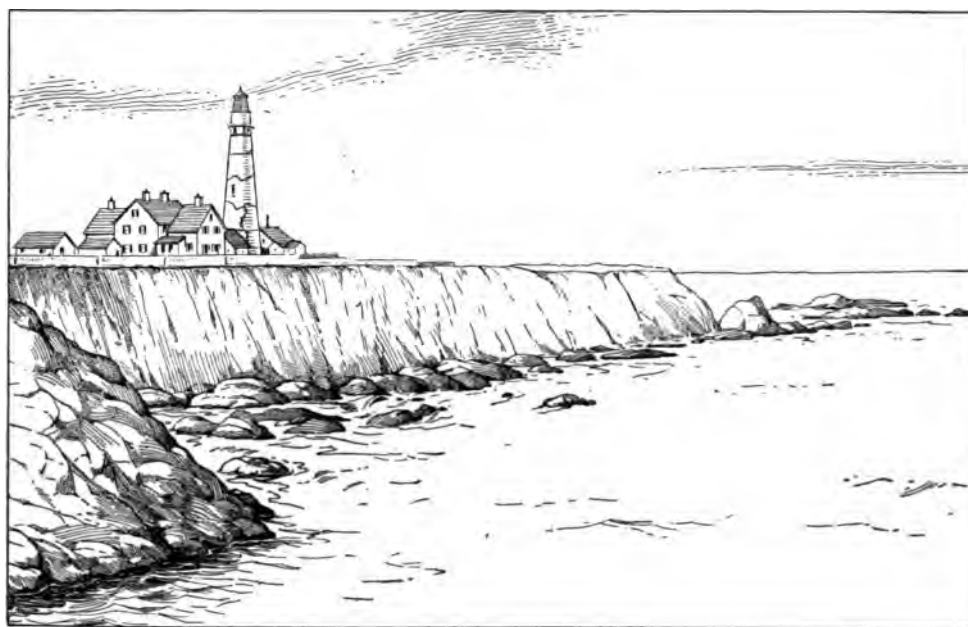
FIG. 49. — Cracks in light-house tower, Point Arena.

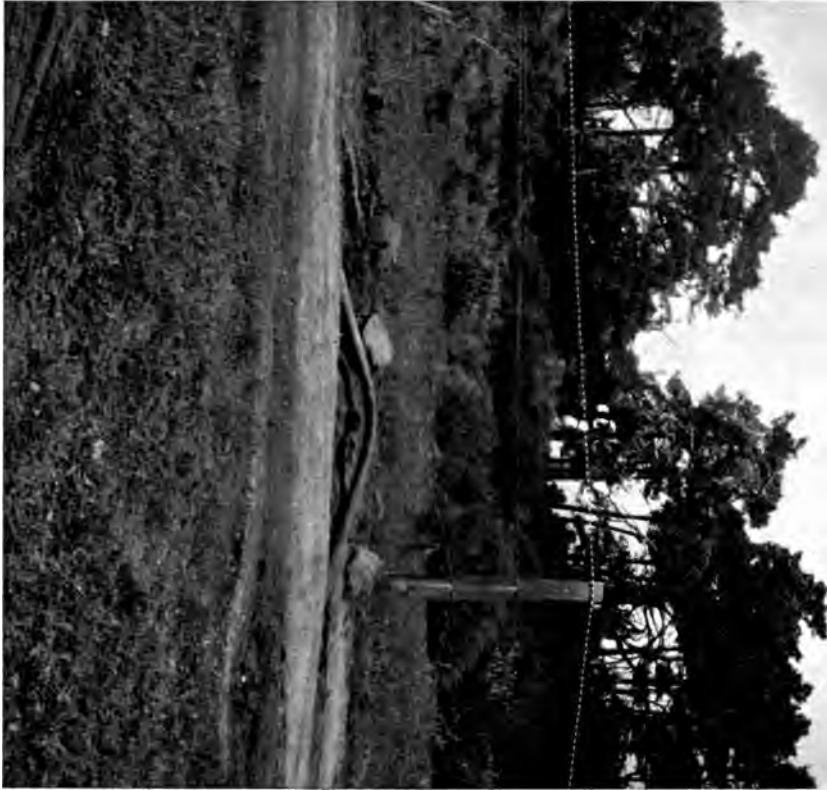
A. Buckled water-pipe, Inverness. G. K. G.

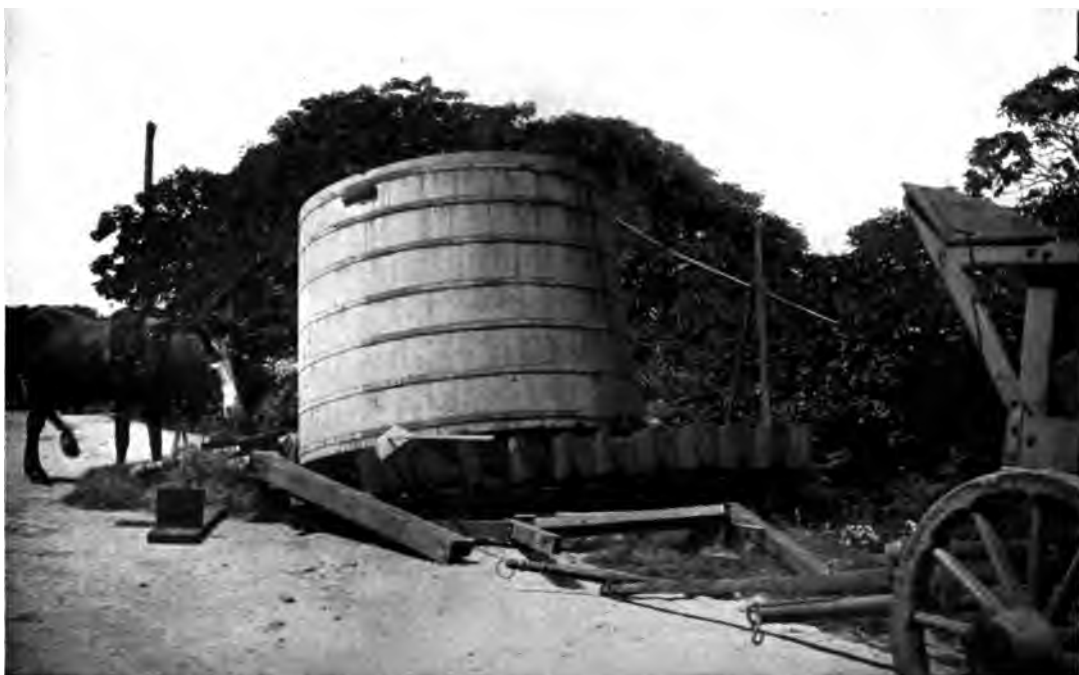
B. Wrecked water-tank near Inverness. G. K. G.

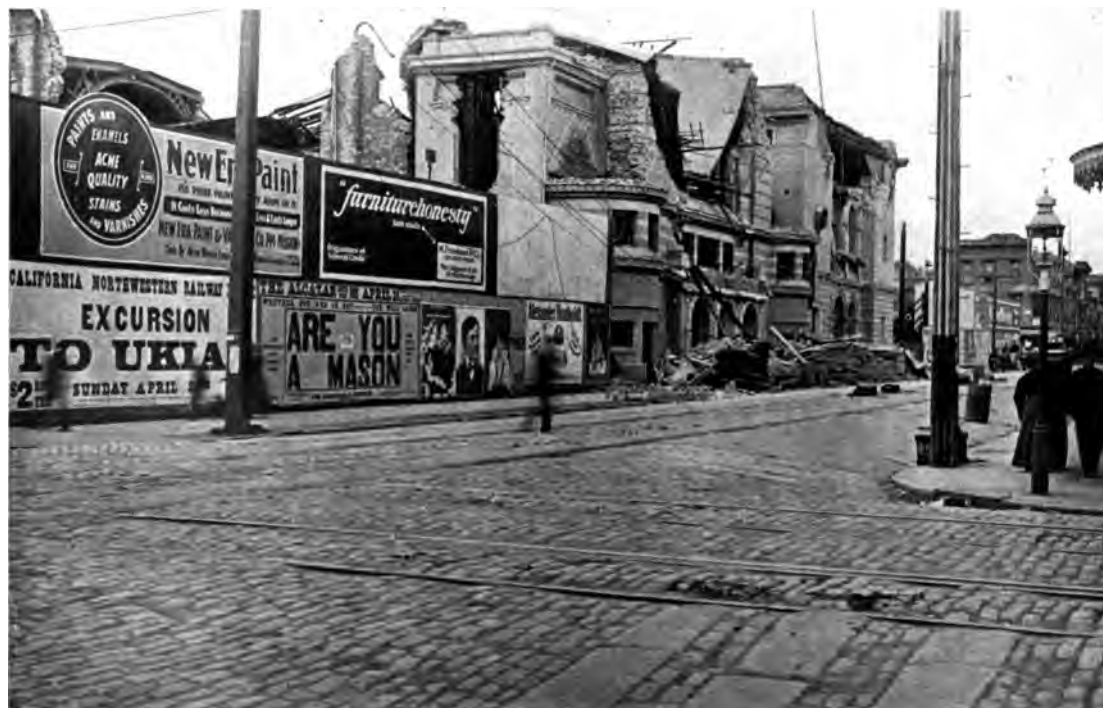
B. Geary Street, between Filmore and Steiner Streets, San Francisco. Buildings of mediocre construction on sand and alluvium of no great depth. A. C. L.

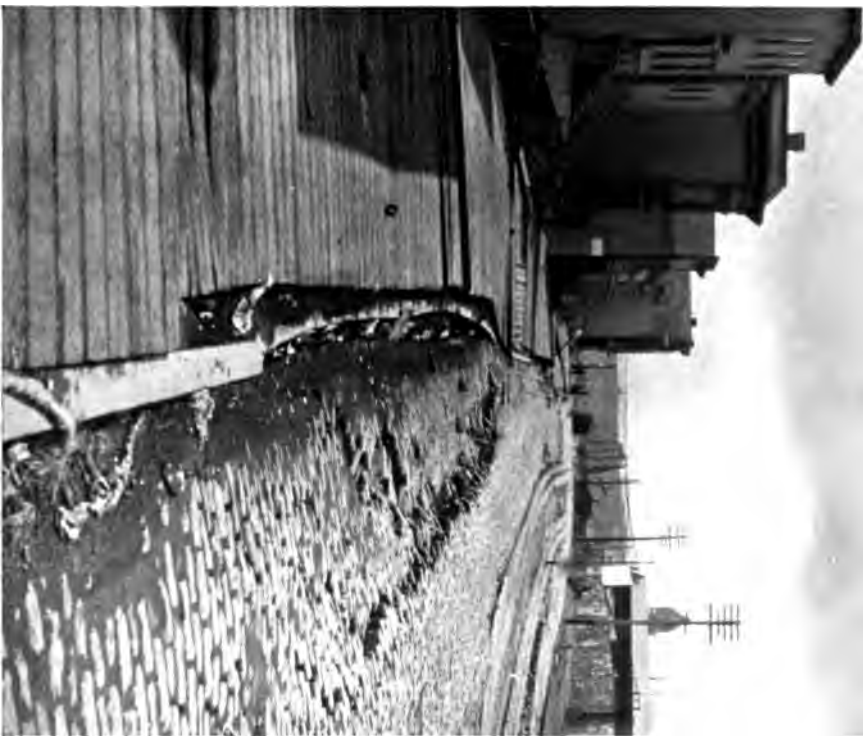
**B. Ninth Street, between Bryant and Brannan. Westward lurching of land toward former creek channel where Dore Street now is. G. K. G.**

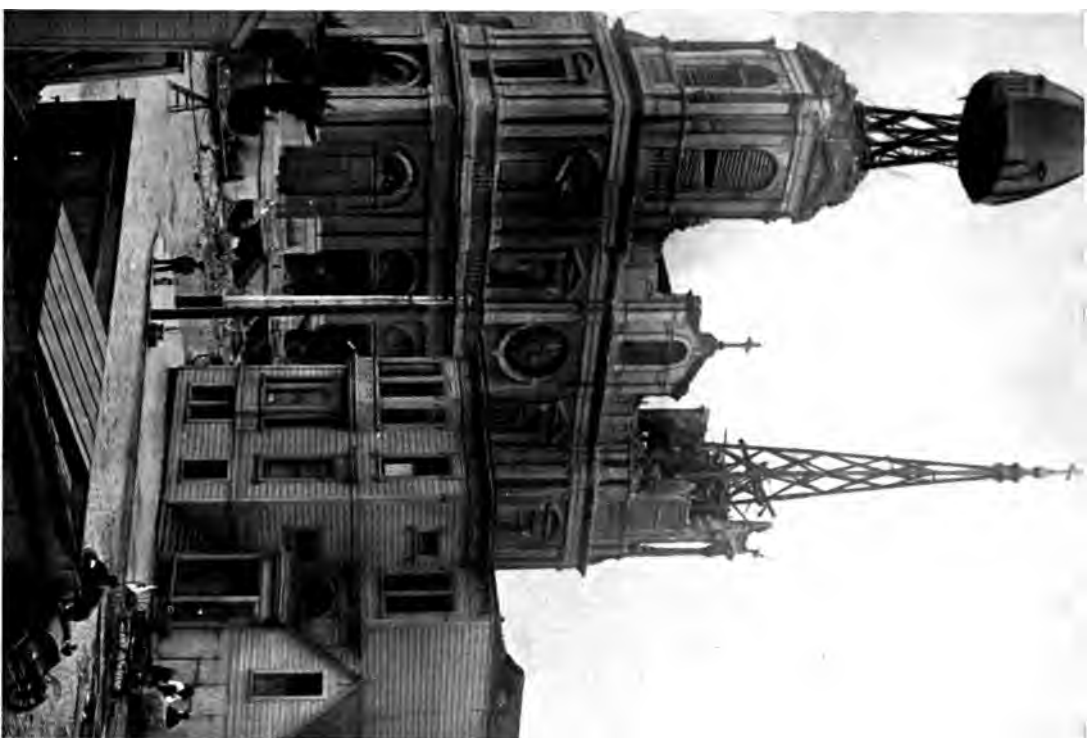
A. St. Dominic's Church, Bush and Steiner Streets. Brick and masonry structure upon sand and alluvium of no great depth. A. C. L.

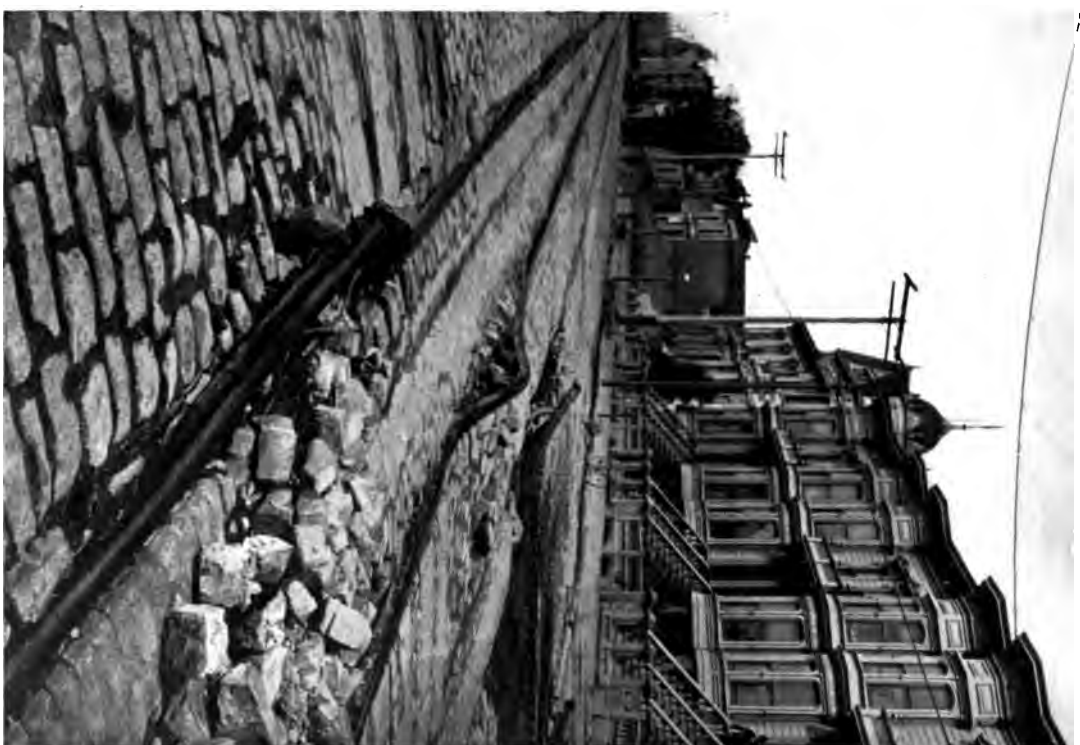
B. Looking south on Howard Street from near Seventeenth Street. Compression of car rails. G. K. G.

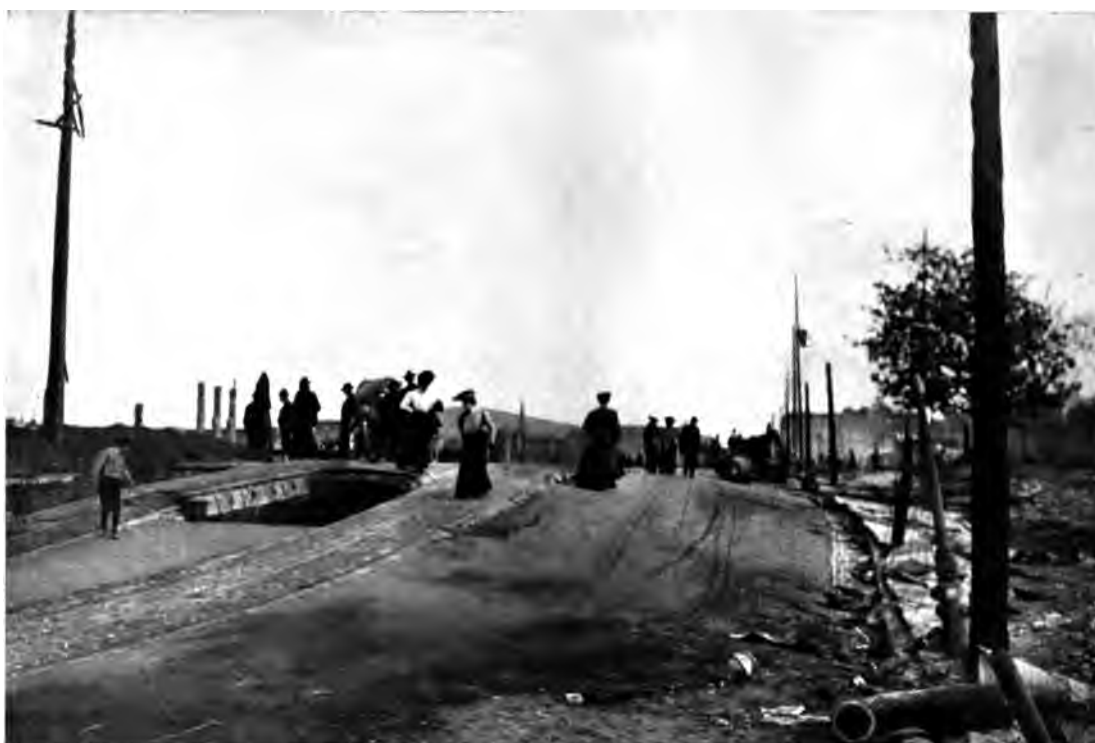
B. Valencia Street, near Eighteenth. Land in this neighborhood sank about 6 feet, flexing street surface. A. C. L.
